# Manhole Inspection Summary

Manhole # S33QQ\_035MH

Insp Date: **10/23/07 11:07 AM**

**Location** Address: **138 25TH ST**

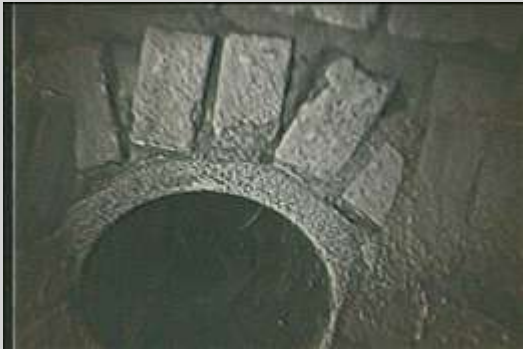
### 8 in. Circular Gravity Sewer Pipe Out @ 12 O'Clock

Rod and Bar (Angled)

Infiltration: **None** Pipe Seal Cond: **Unknown**
